ASBESTOS SURVEY FOR THE SUPPLEMENTAL REMEDIAL INVESTIGATION

**Presidio of San Francisco
Modification to Phase II Environmental Study**

**Contract No. DAAA15-90-D-0018
Task Order 0002, Data Item A004**

**Prepared by:
Watkins-Johnson Environmental, Inc.**

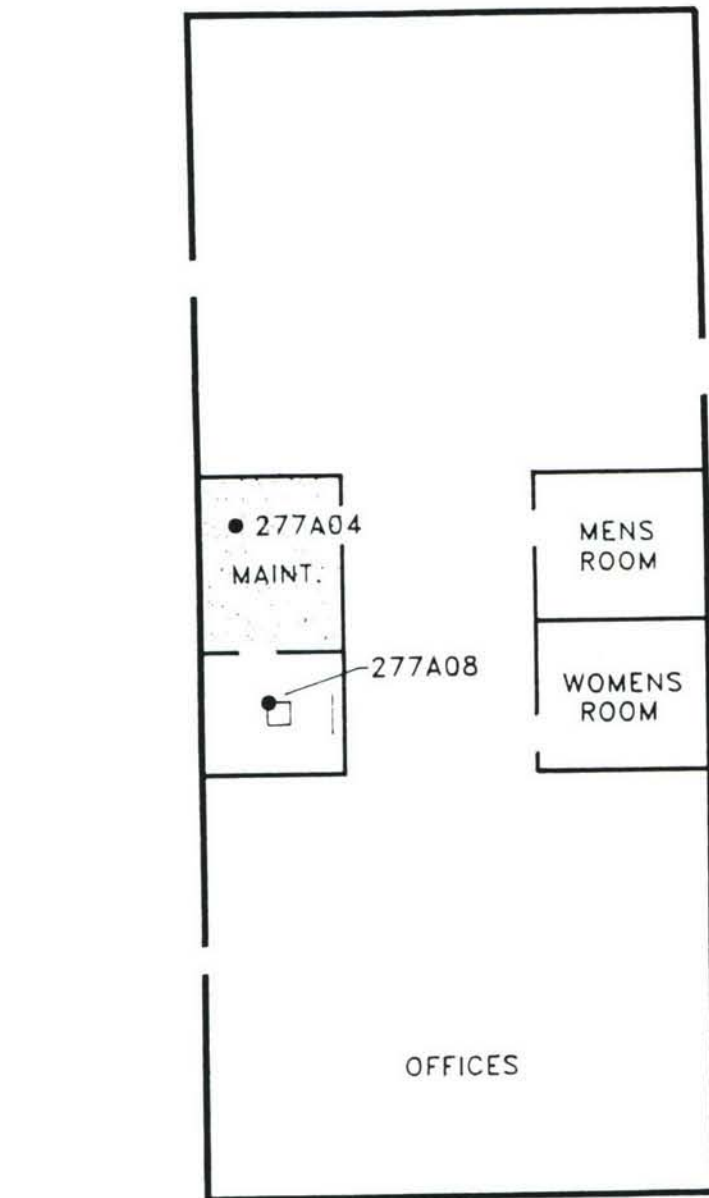
- ASBESTOS SAMPLING LOCATION
- OFF-WHITE NON-ASBESTOS FLOOR TILE WITH AN ASBESTOS-CONTAINING MASTIC (SAMPLE I.D. 277A04)
- ASBESTOS CONTAINING DUCT-TAPE (SAMPLE I.D. 277A08)

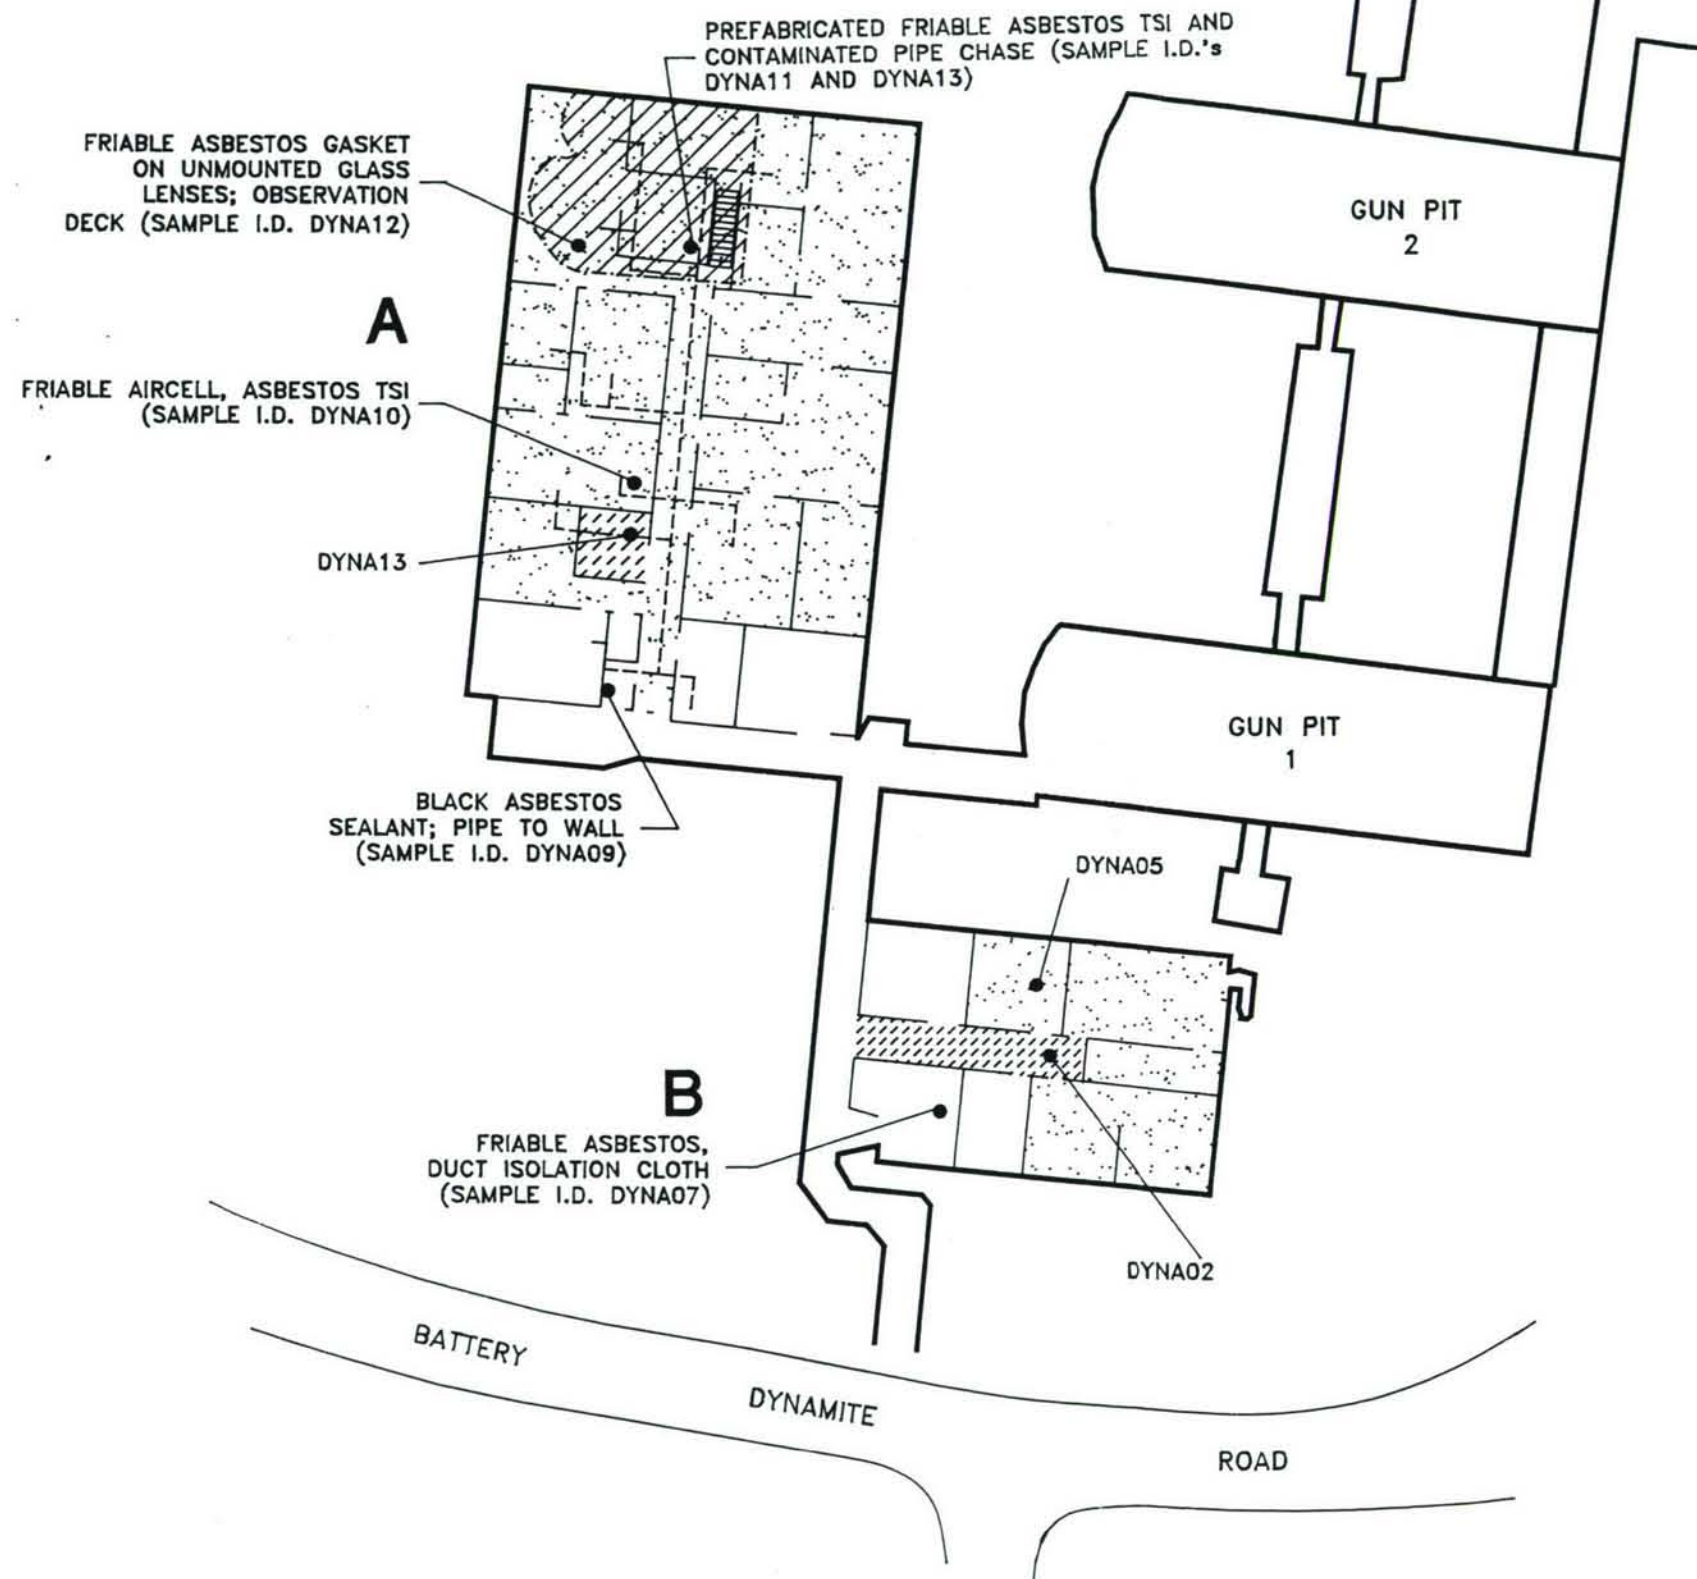
**BATTERY DYNAMITE
BUILDING 1399
ASBESTOS CONTAINING
MATERIALS LOCATIONS**

Battery Dynamite is constructed almost entirely of concrete; however, subsequent renovations made in increments included materials, friable and nonfriable, that were analyzed and found to contain asbestos. Thirteen bulk samples were collected during the building survey, eight of which tested positive for asbestos. Of the eight confirmed positives, five were friable. A partial floorplan of the building with all the sample locations is presented as Figure 3.6. Asbestos sample results for Battery Dynamite are presented in Table 3.4. Figure 3.7 delineates the approximate extent of the asbestos containing floor tiles, floor tile mastic, air cell and prefabricated thermal system insulation (TSI), gaskets and sealant.

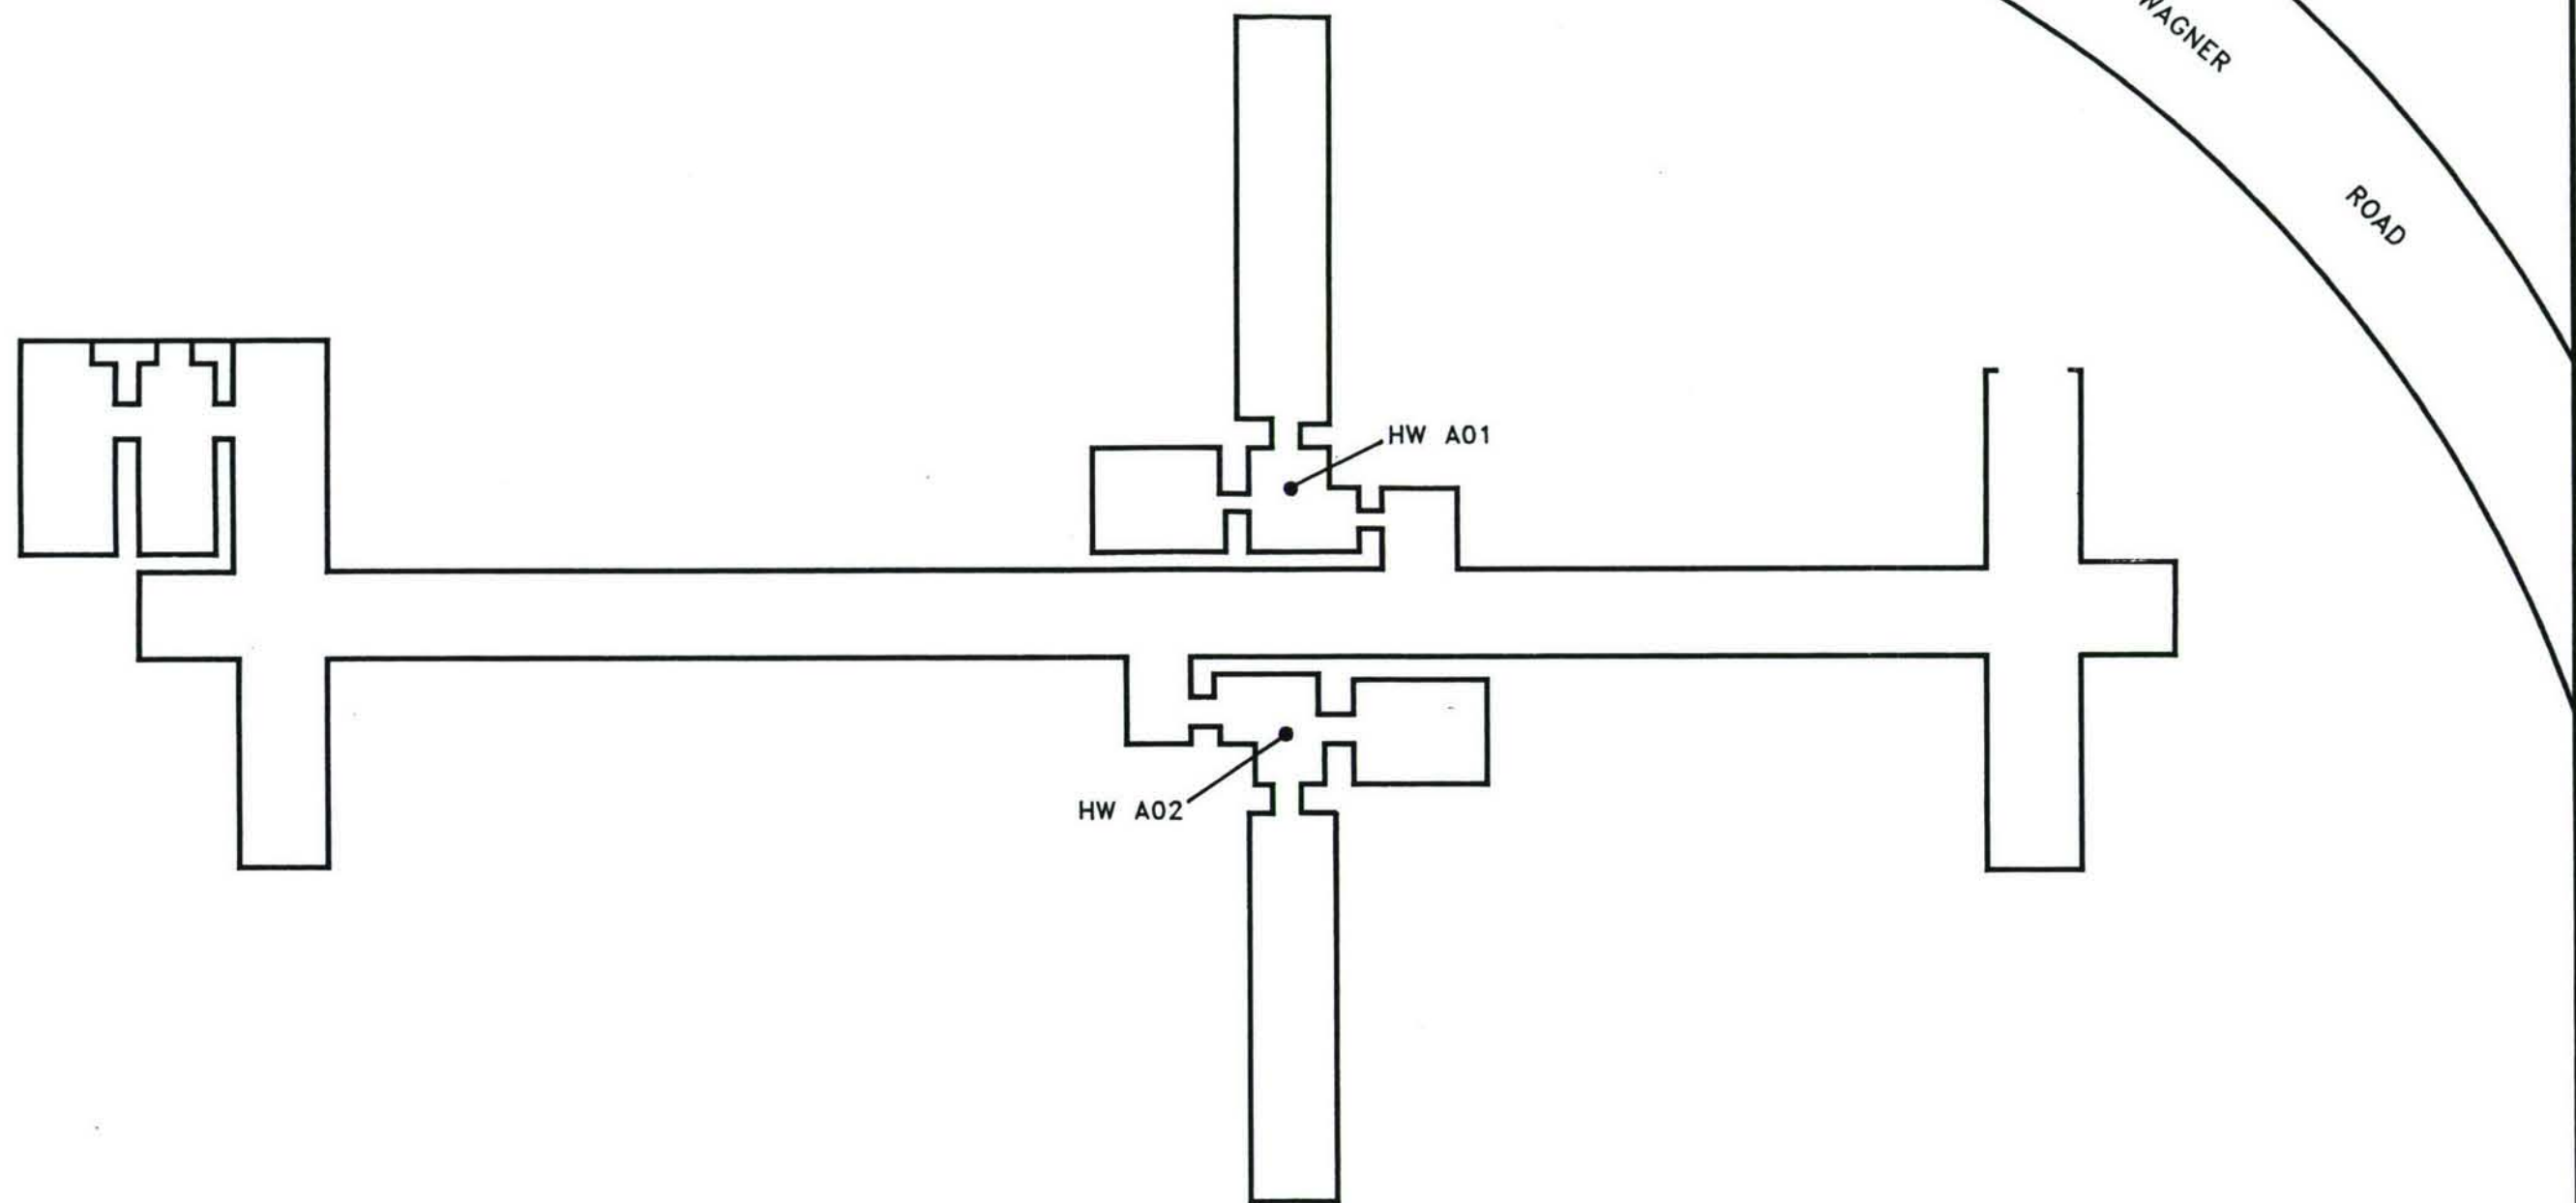
No suspected asbestos construction materials were identified during the walkthrough; however, suspect friable ACM debris was found and sampled from two piles on the floor. Both samples tested positive for asbestos. A floorplan of the building with the sample locations is presented as Figure 3.8. Asbestos sample results for Battery Howe-Wagner are presented in Table 3.6. The source of the ACM debris is

apparently boiler wrap or TSI removed elsewhere. The most apparent piles of ACM debris are estimated to total less than 100 ft²; however, given the manner in which this waste asbestos was transported into the building and discarded, asbestos dust contamination of most of the building's 3,000 ft² cannot be discounted. Battery Howe-Wagner should remain securely closed until a remedial cleaning of the asbestos debris and dust contamination is completed.

Battery Howe-Wagner should remain securely closed until a remedial cleaning of the asbestos debris and dust contamination is completed. It should be noted that oxygen levels monitored during the site entry were slightly less than the acceptable Occupational Safety and Health Administration (OSHA) minimum (19.5% O₂). Asbestos removal in Battery Dynamite is recommended before any restoration or re-use of the structure. Implementation of an Operations and Maintenance (O&M) program is recommended for Building 277 and removal of the asbestos duct tape is recommended prior to any renovation or demolition in the maintenance/storage area. The friable lens gaskets remaining in the New Mine Casemate do not pose a potential hazard if left undisturbed and could be easily collected for appropriate disposal.

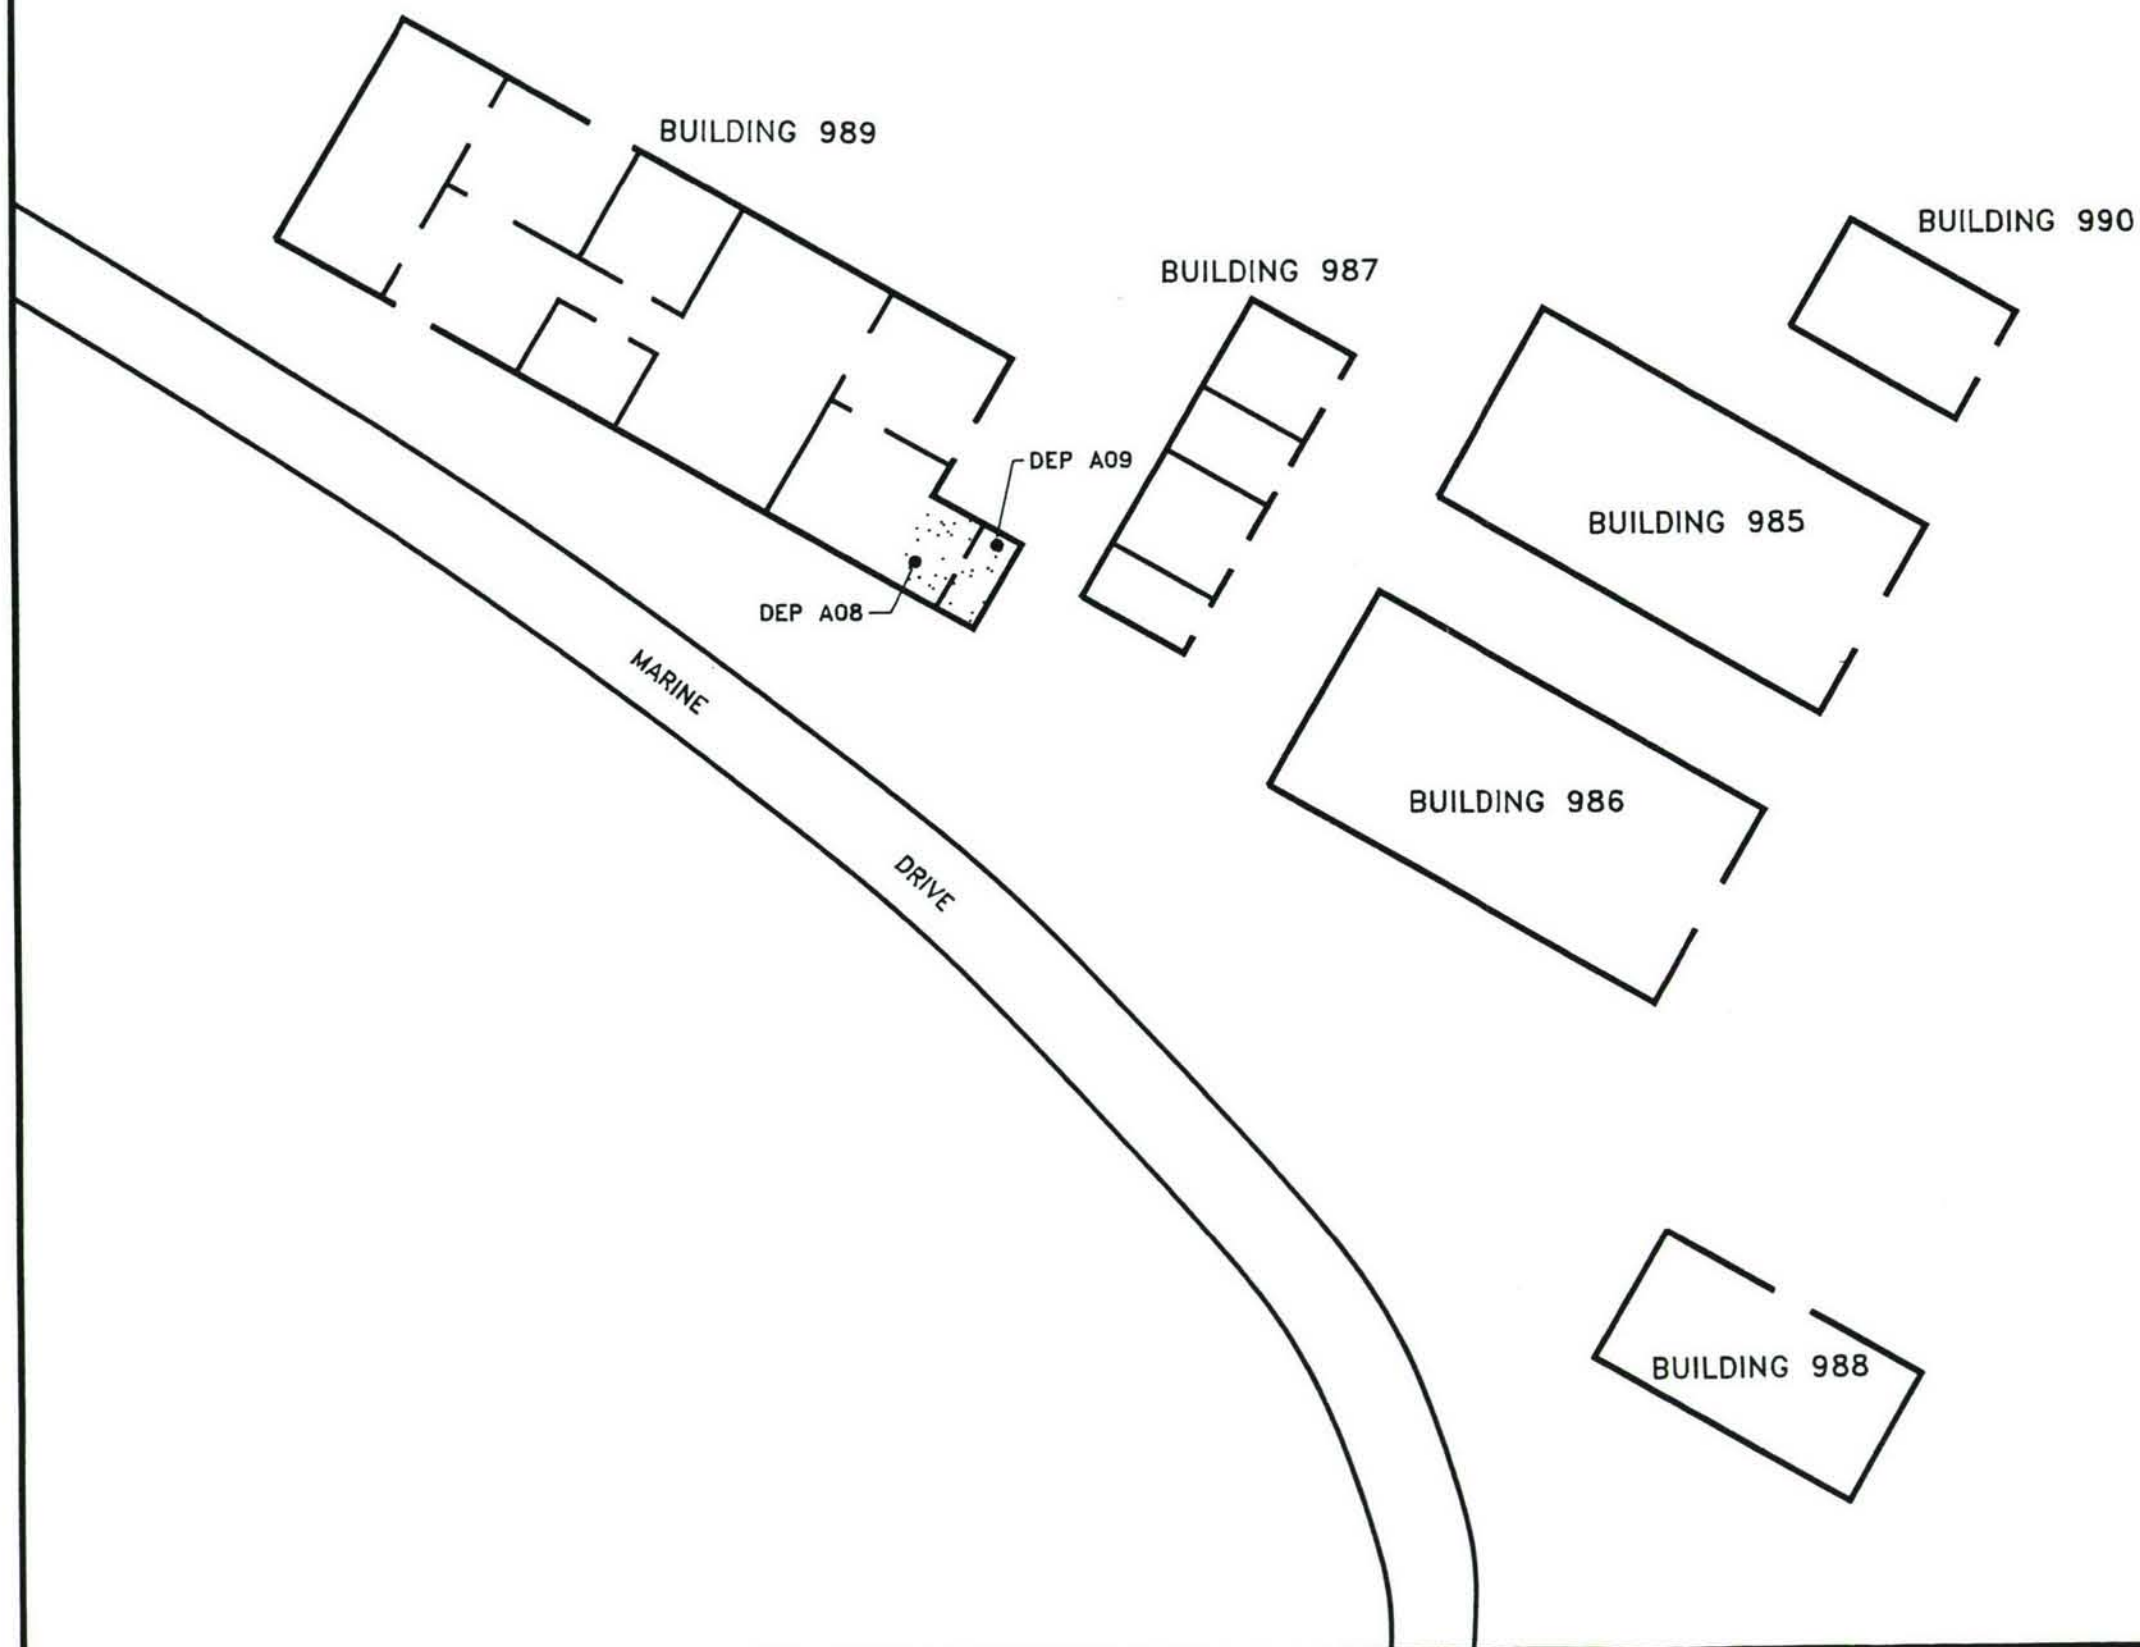
Building 989 is the Park Headquarters, an occupied structure with offices, a locker room, restrooms and a meeting room. Eleven samples of suspected ACM were collected in this building, two tested positive for nonfriable asbestos. Collected for analyses were two samples of ceiling tile, two samples of roofing materials, five samples of flooring materials and one each of a baseboard and a ceiling insulation. Of these materials, two samples of floor sheeting from restrooms, with a total area of about 100 ft², tested positive, but are nonfriable and in fair condition. Asbestos sample results for Building 989 are presented in Table 3.9. Figure 3.10 delineates the extent of the asbestos containing backing on vinyl sheeting found on floors and walls.

- ASBESTOS SAMPLING LOCATION
- EXTENT OF VINYL SHEETING WITH ASBESTOS CONTAINING BACKING; ON FLOORS AND WALLS (SAMPLE I.D.'s DEPA09)
